Monthly Oversight Report 64  
44728 AES [46526 RAC]  
ACS NPL Site  
Griffith, Indiana  
April 1, 2006 – May 5, 2006

Subject: Monthly Oversight Summary Report  
No. 64 for April 2006

**Monthly Oversight Summary Report No. 64**  
**ACS Superfund Site**  
**TO 057, 44728.238 (AES) [WA57, 46526.238 (RAC)]**

**Reporting Period:** Month of April (April 1 through May 5, 2006)

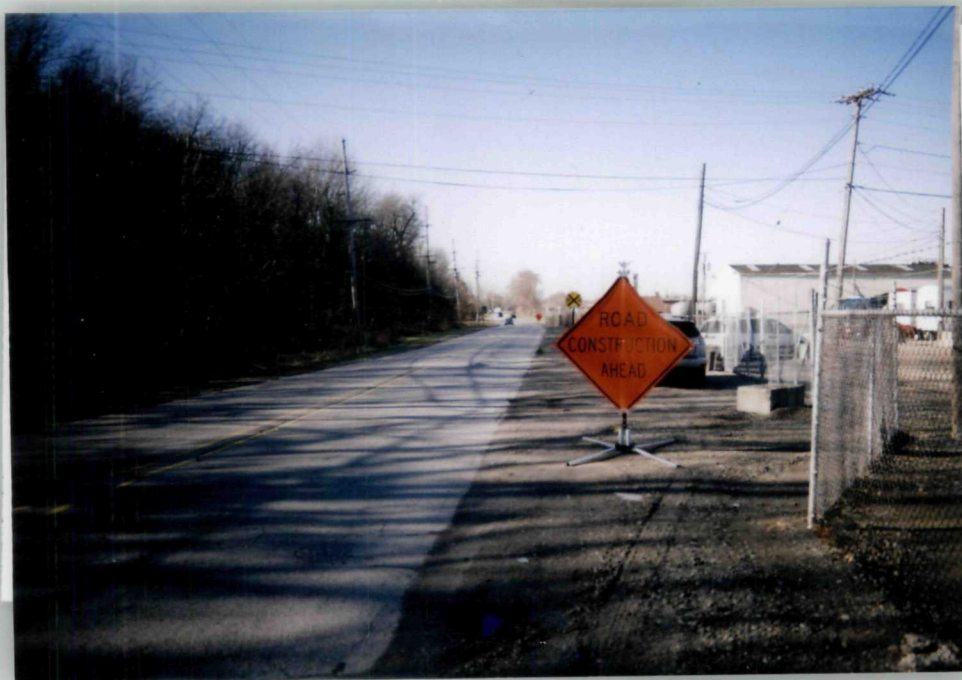
Site: American Chemical Service, Inc.  
Proj. #: 44728 AES [46526 RAC]  
Roll: 84 Photo #9  
Date: 4-04-06 Time: 0839  
Photographer: Larry Campbell  
Description: Photo facing south showing work zone  
signs set up before lane is closed ahead.

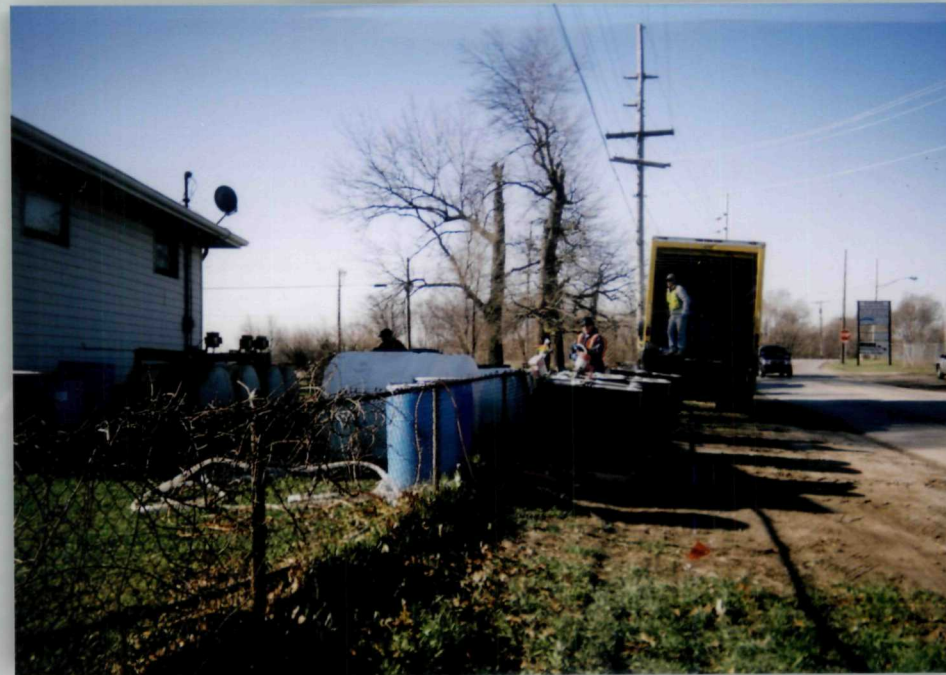
Site: American Chemical Service, Inc.  
Proj. #: 44728 AES [46526 RAC]  
Roll: 84 Photo #10  
Date: 4-04-06 Time: 0846  
Photographer: Larry Campbell  
Description: Photo facing south showing ISOTEC  
setting up injection tanks, pumps and  
chemical drums on east side of Colfax  
Ave.

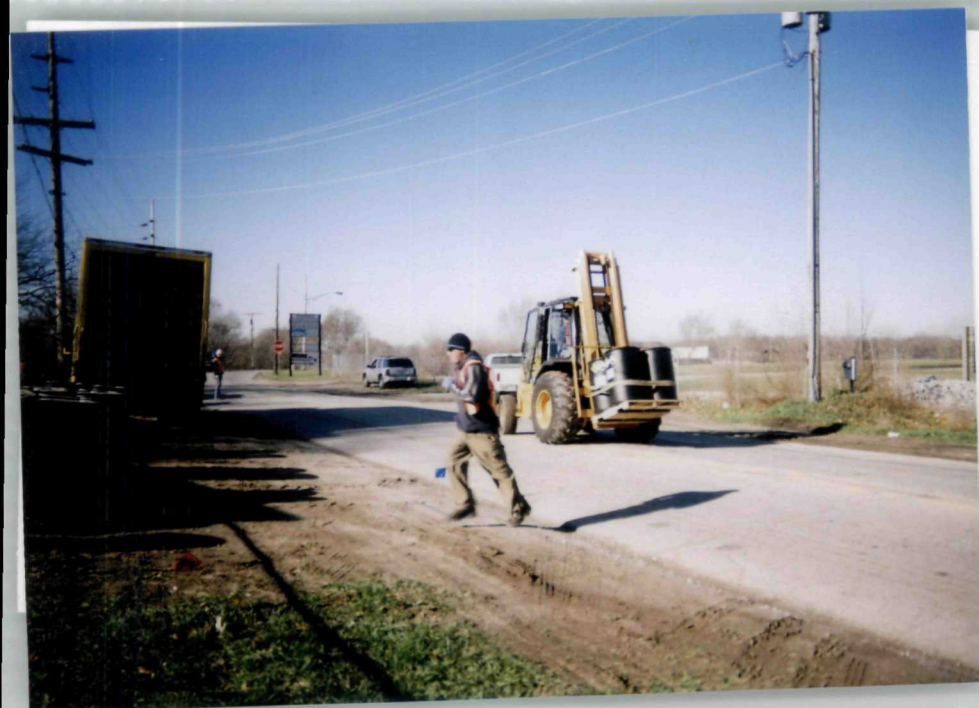
Site: American Chemical Service, Inc.  
 Proj. #: 44728 AES [46526 RAC]  
 Roll: 84 Photo #11  
 Date: 4-04-06 Time: 0847  
 Photographer: Larry Campbell  
 Description: Photo facing southwest showing  
 ISOTEC moving drums of hydrogen  
 peroxide from the large tanker truck to  
 the work area.

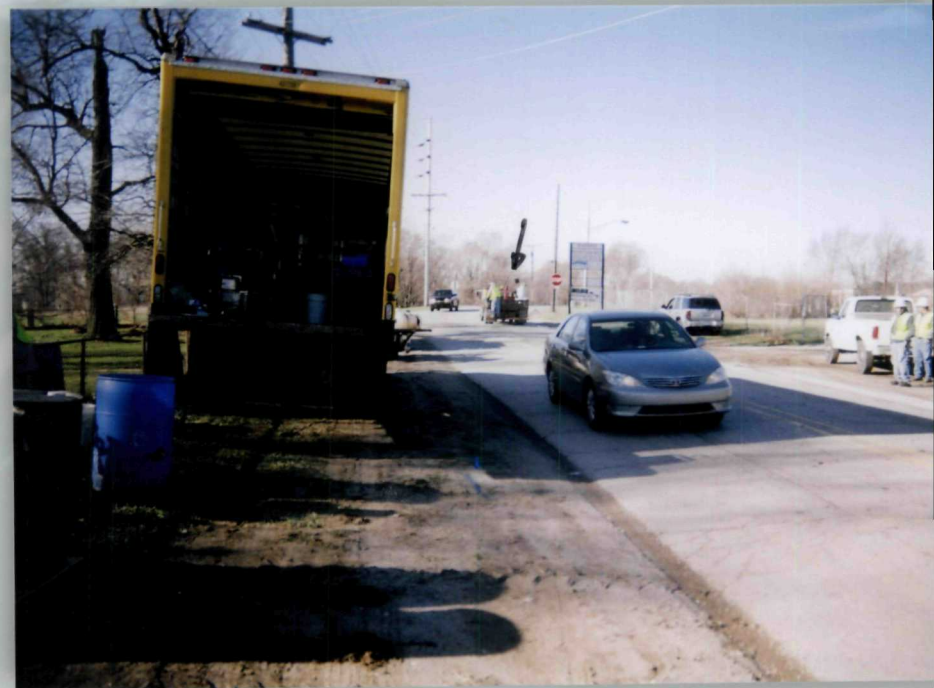
Site: American Chemical Service, Inc.  
 Proj. #: 44728 AES [46526 RAC]  
 Roll: 84 Photo #12  
 Date: 4-04-06 Time: 0850  
 Photographer: Larry Campbell  
 Description: Photo facing south showing Walsh &  
 Kelly placing traffic cones down center  
 of Colfax Ave. to divert traffic.

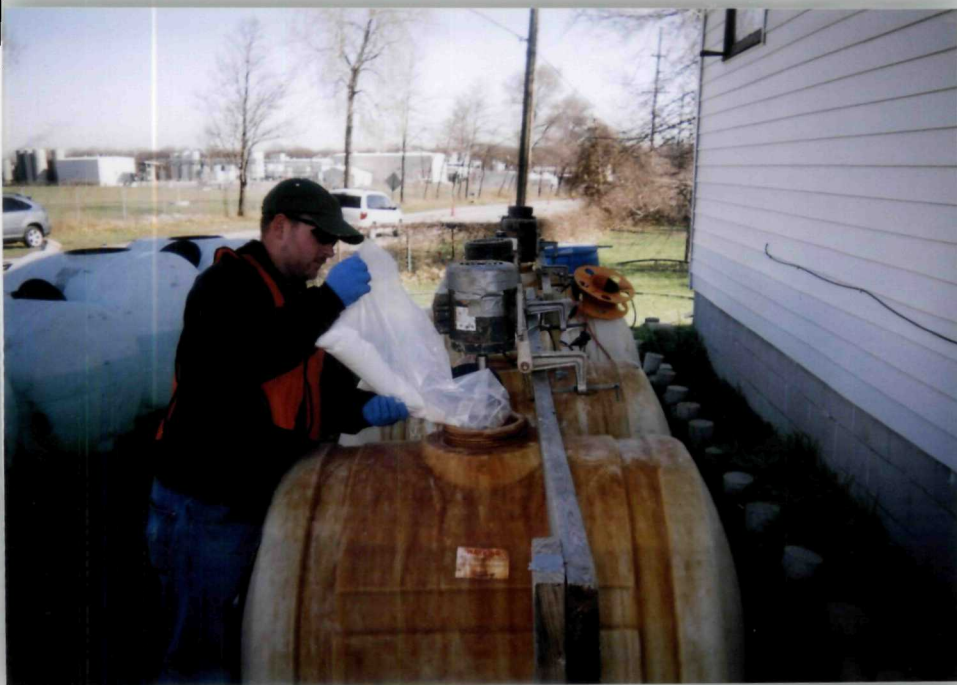
Site: American Chemical Service, Inc.  
Proj. #: 44728 AES [46526 RAC]  
Roll: 84 Photo #13  
Date: 4-04-06 Time: 0855  
Photographer: Larry Campbell

Description: Photo facing north showing ISOTEC adding catalyst powder to tank of water to mix into solution.

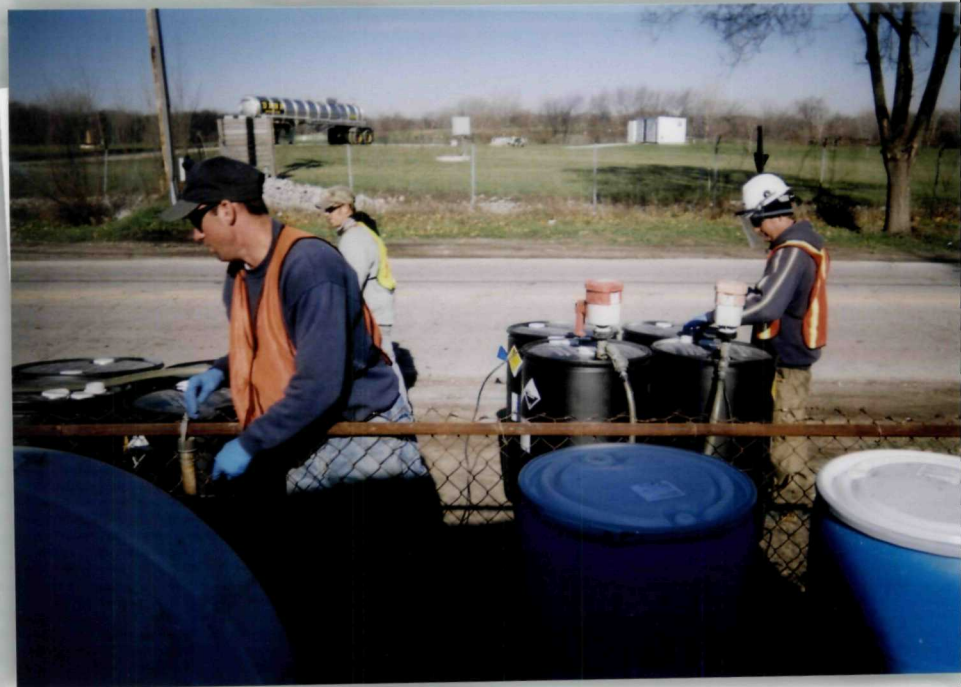
Site: American Chemical Service, Inc.  
Proj. #: 44728 AES [46526 RAC]  
Roll: 84 Photo #14  
Date: 4-04-06 Time: 0902  
Photographer: Larry Campbell

Description: Photo facing west showing ISOTEC operating pumps to transfer hydrogen peroxide to tanks. Note staff wearing splash protection head gear.

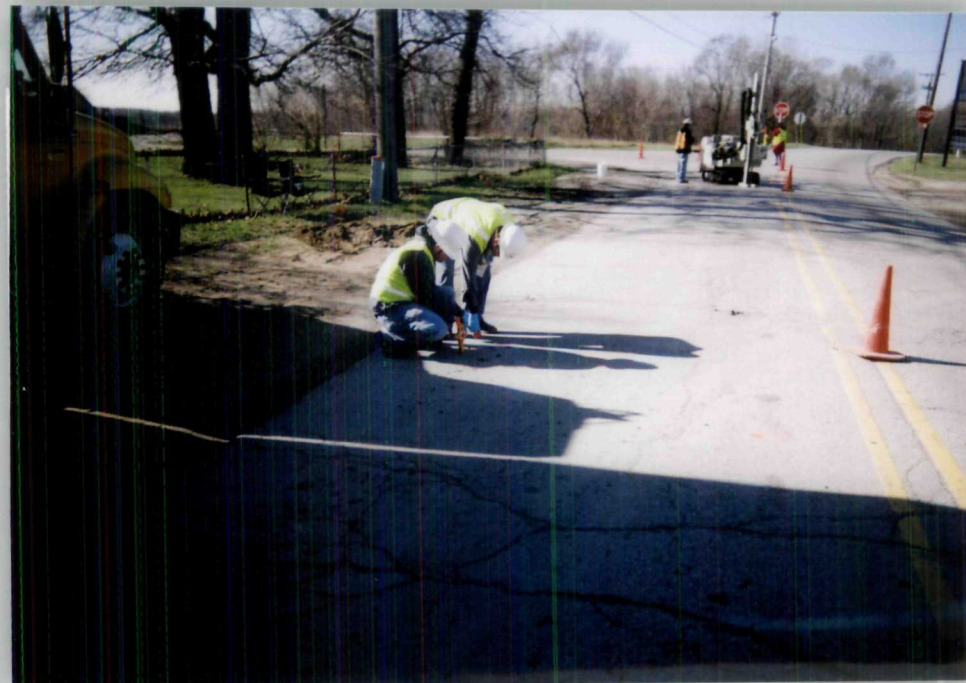
Site: American Chemical Service, Inc.  
 Proj. #: 44728 AES [46526 RAC]  
 Roll: 84 Photo #15  
 Date: 4-04-06 Time: 0912  
 Photographer: Larry Campbell  
 Description: Photo facing south showing MWH marking injection locations in roadway of Colfax Ave.

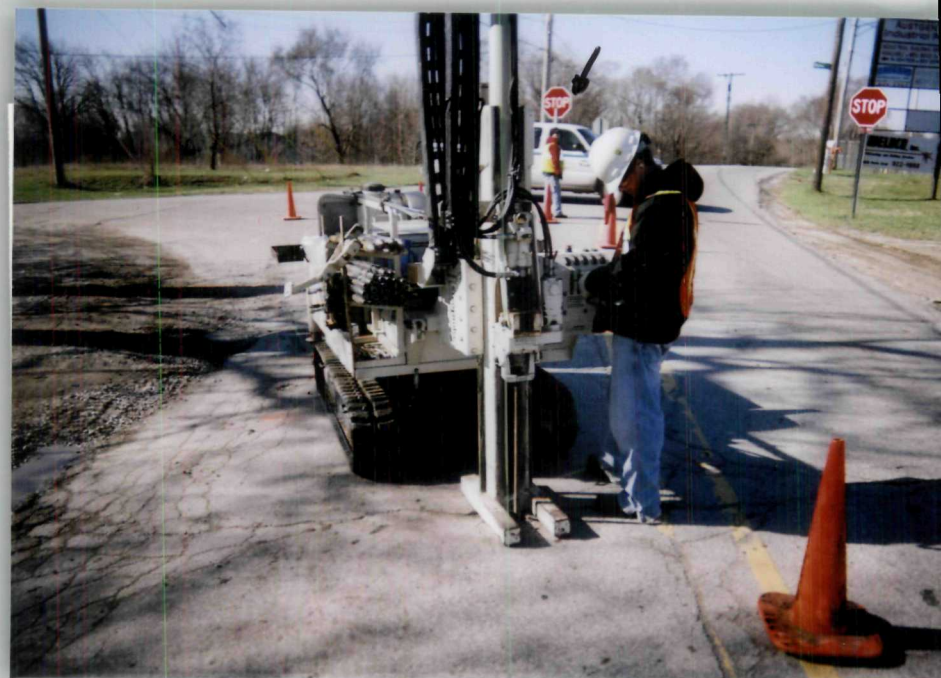
Site: American Chemical Service, Inc.  
 Proj. #: 44728 AES [46526 RAC]  
 Roll: 84 Photo #16  
 Date: 4-04-06 Time: 0915  
 Photographer: Larry Campbell  
 Description: Photo facing south showing PSA Environmental drilling first hole through asphalt. Note flagger in background.

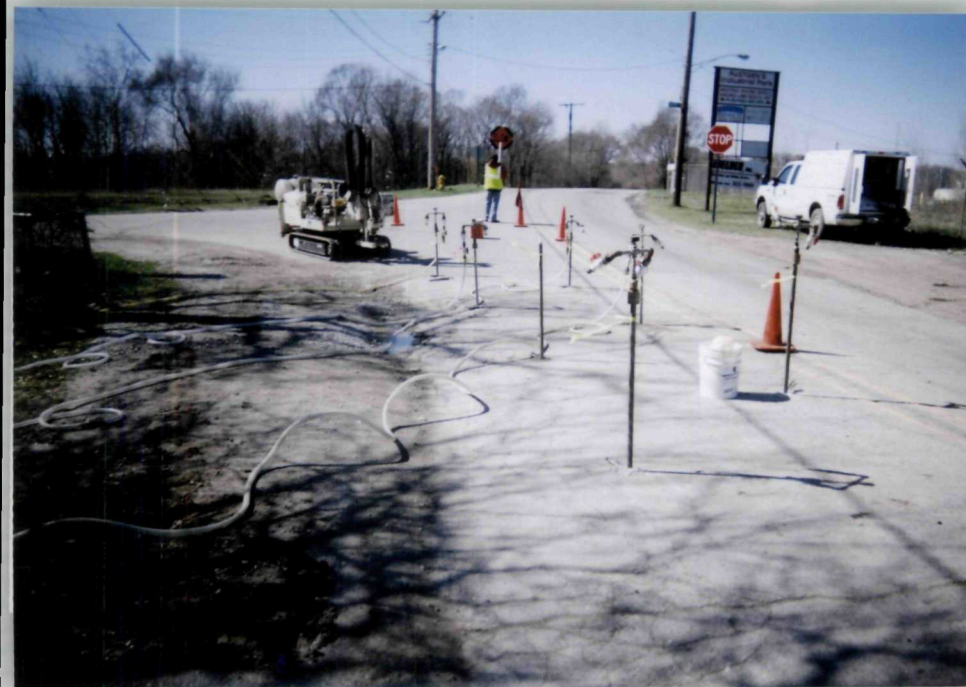
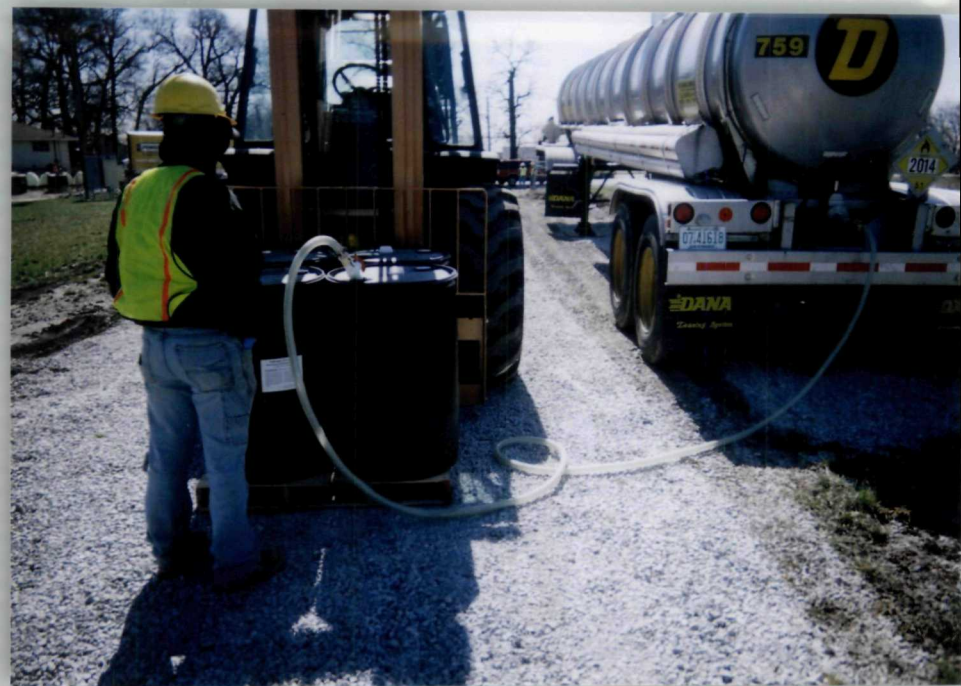
Site: American Chemical Service, Inc.  
Proj. #: 44728 AES [46526 RAC]  
Roll: 84 Photo #17  
Date: 4-04-06 Time: 1037  
Photographer: Larry Campbell  
Description: Photo facing south showing four injection points being injected with chemox solution. Note other injection points are installed to expedite operation.

Site: American Chemical Service, Inc.  
Proj. #: 44728 AES [46526 RAC]  
Roll: 84 Photo #18  
Date: 4-04-06 Time: 1045  
Photographer: Larry Campbell  
Description: Photo facing east showing ISOTEC transferring hydrogen peroxide from tanker to drums.

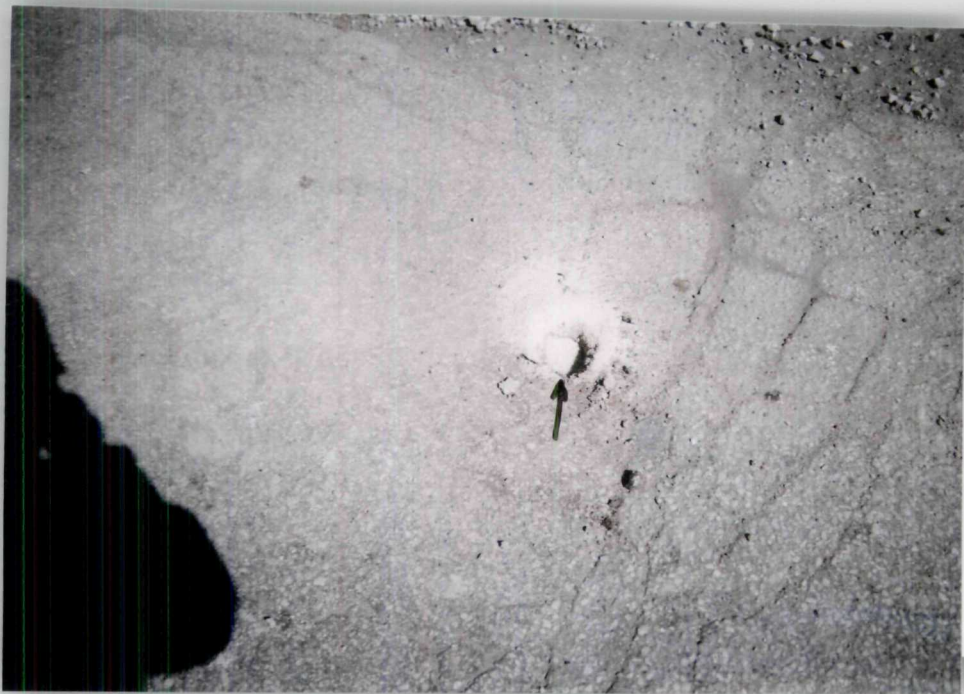
Site: American Chemical Service, Inc.  
 Proj. #: 44728 AES [46526 RAC]  
 Roll: 84 Photo #19  
 Date: 4-04-06 Time: 1415  
 Photographer: Larry Campbell  
 Description: Photo facing down showing sand used to  
 backfill the hole drilled through the  
 asphalt roadway.

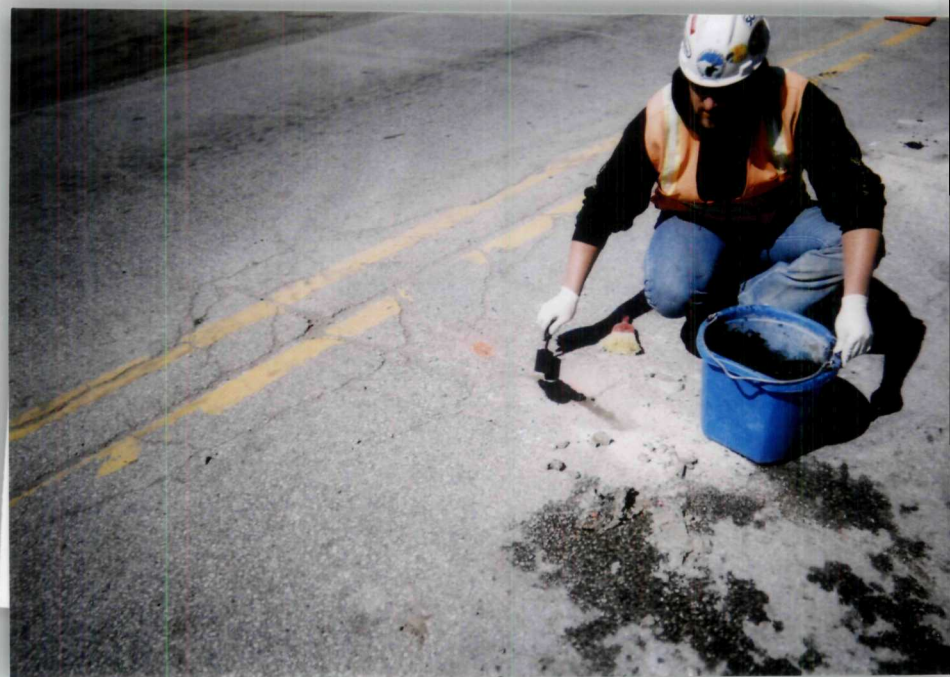
Site: American Chemical Service, Inc.  
 Proj. #: 44728 AES [46526 RAC]  
 Roll: 84 Photo #20  
 Date: 4-04-06 Time: 1417  
 Photographer: Larry Campbell  
 Description: Photo facing north showing PSA  
 patching hole in asphalt roadway.

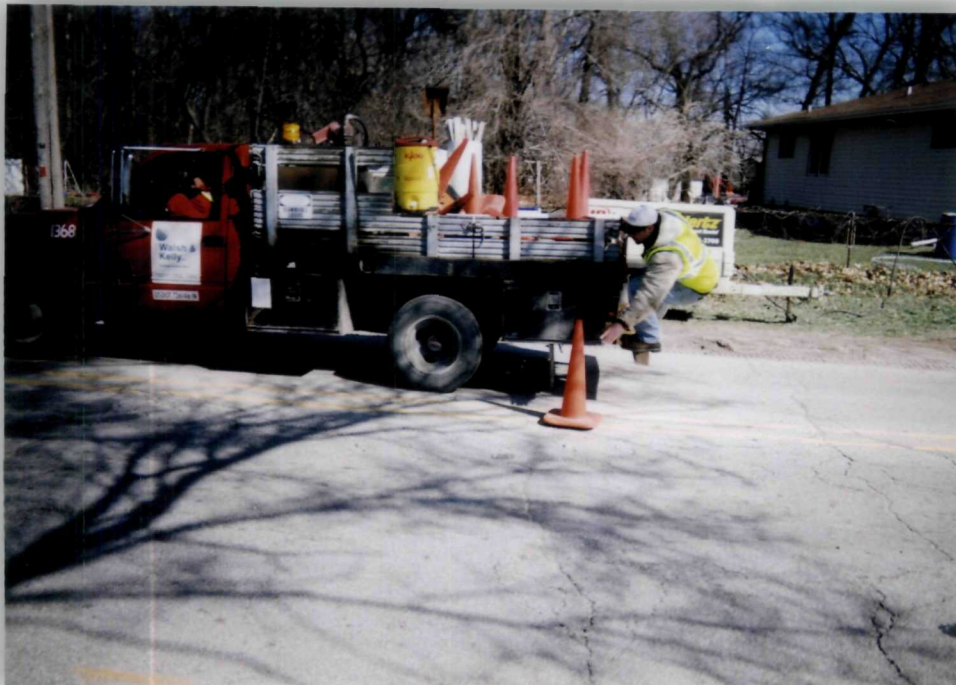
Site: American Chemical Service, Inc.  
Proj. #: 44728 AES [46526 RAC]  
Roll: 84 Photo #21  
Date: 4-04-06 Time: 1529  
Photographer: Larry Campbell  
Description: Photo facing east showing Walks and Kelly picking up traffic cones. Work in roadway is completed for the day. Now working in east shoulder of Colfax Ave.

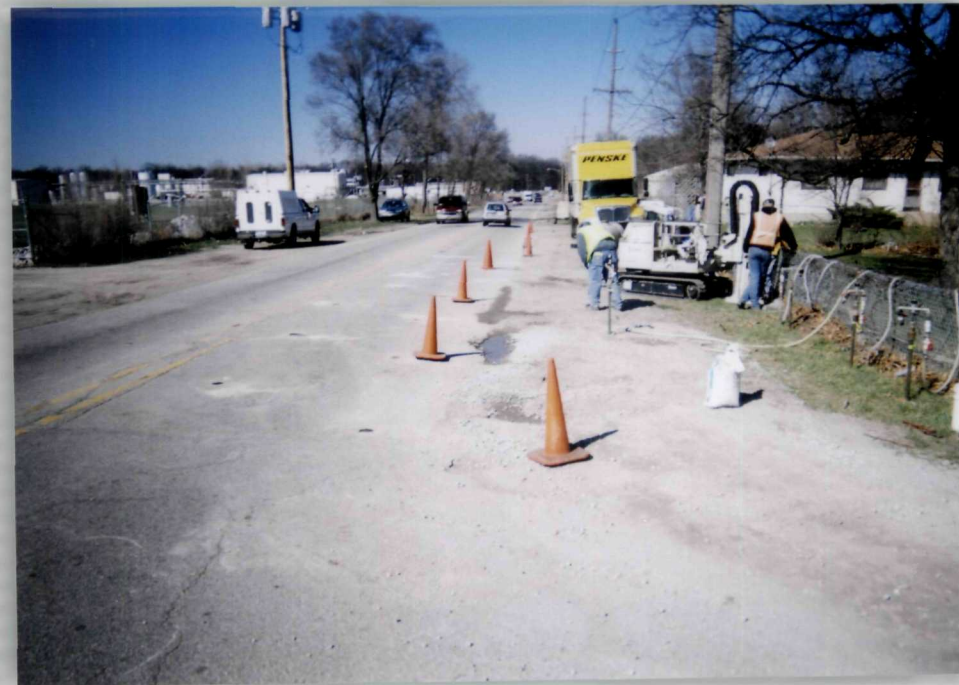
Site: American Chemical Service, Inc.  
Proj. #: 44728 AES [46526 RAC]  
Roll: 84 Photo #22  
Date: 4-04-06 Time: 1538  
Photographer: Larry Campbell  
Description: Photo facing north showing traffic cones placed while working on shoulder on Colfax Avenue.

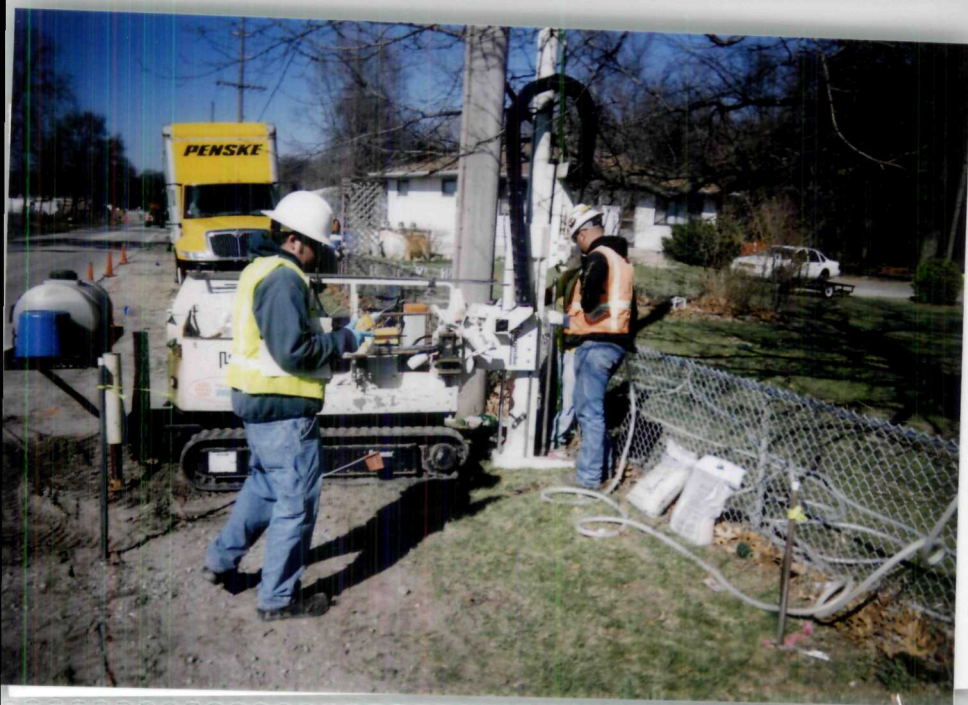
Site: American Chemical Service, Inc.  
 Proj. #: 44728 AES [46526 RAC]  
 Roll: 84 Photo #23  
 Date: 4-04-06 Time: 1550  
 Photographer: Larry Campbell  
 Description: Photo facing north showing PSA installing final injection rods for today. Will have injected 22 points today when this point completed.

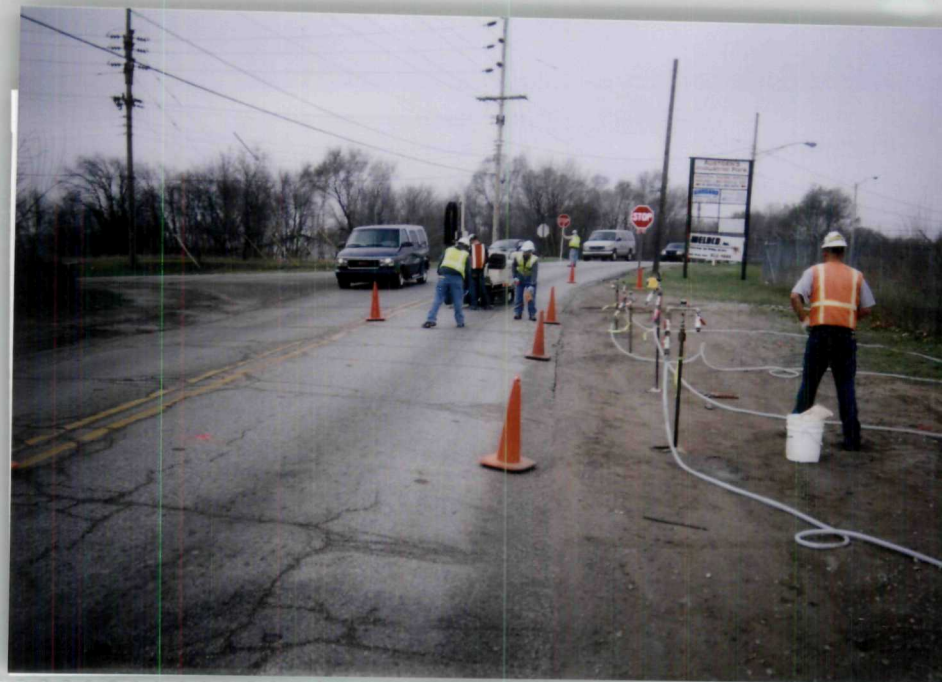
Site: American Chemical Service, Inc.  
 Proj. #: 44728 AES [46526 RAC]  
 Roll: 84 Photo #24  
 Date: 4-07-06 Time: 0910  
 Photographer: Larry Campbell  
 Description: Photo facing south showing chemox injection at 4 locations on shoulder and drilling through asphalt in Colfax Ave.

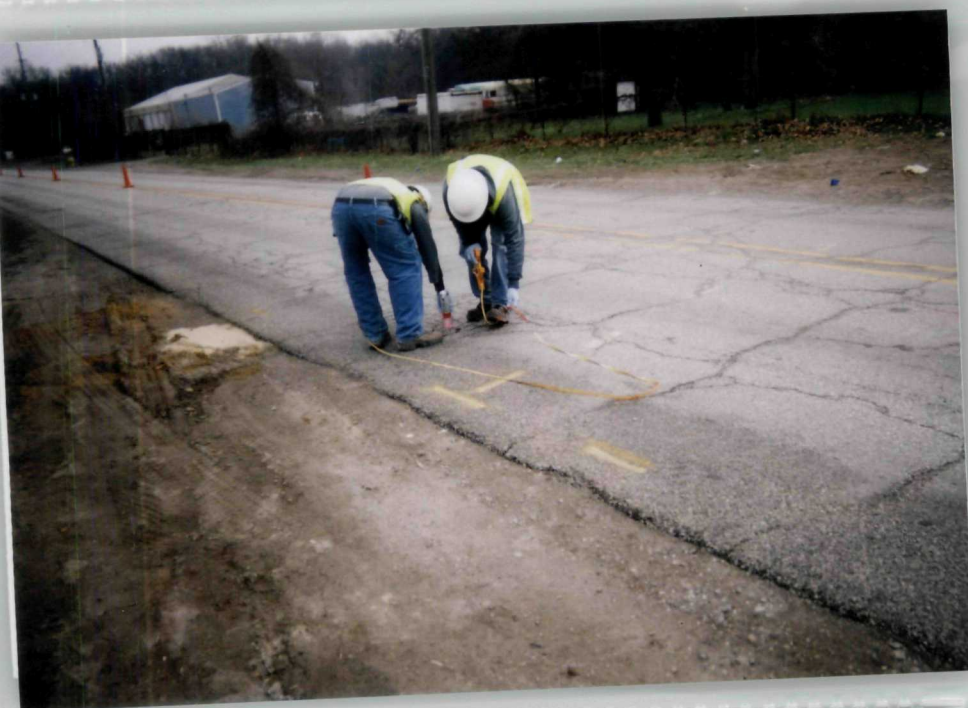
Site: American Chemical Service, Inc.  
Proj. #: 44728 AES [46526 RAC]  
Roll: 84 Photo #25  
Date: 4-07-06 Time: 0914  
Photographer: Larry Campbell  
Description: Photo facing north showing MWH marking locations of chemox injection points in Colfax Ave.

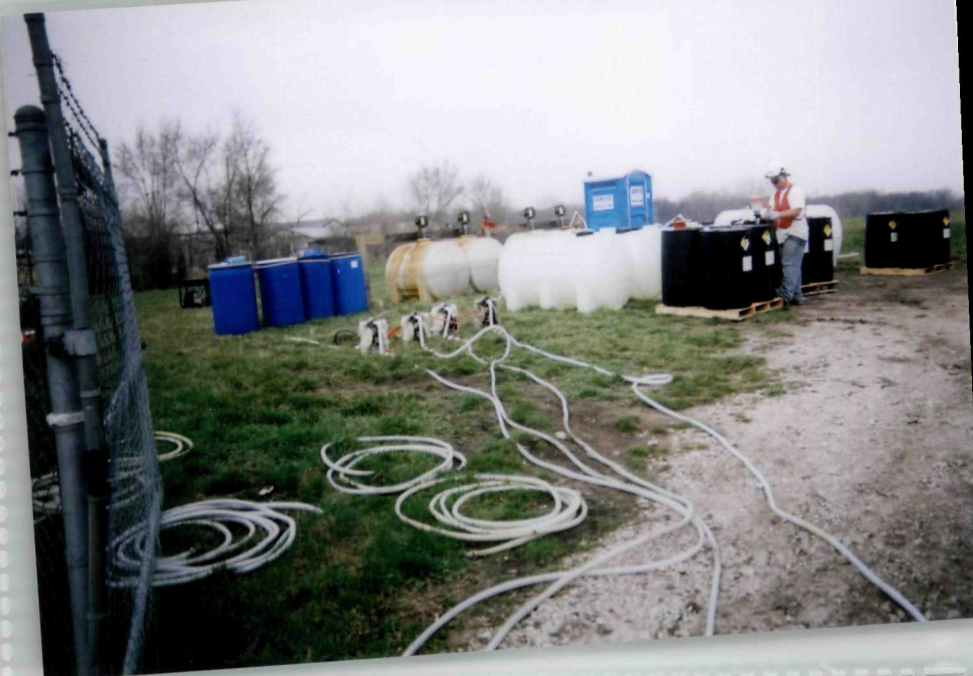
Site: American Chemical Service, Inc.  
Proj. #: 44728 AES [46526 RAC]  
Roll: 84 Photo #26  
Date: 4-07-06 Time: 0915  
Photographer: Larry Campbell  
I Description: PhotofacingsouthwestshowingISOTEC chemox mixing and pumping station set up in OFCA west of Colfax Ave.

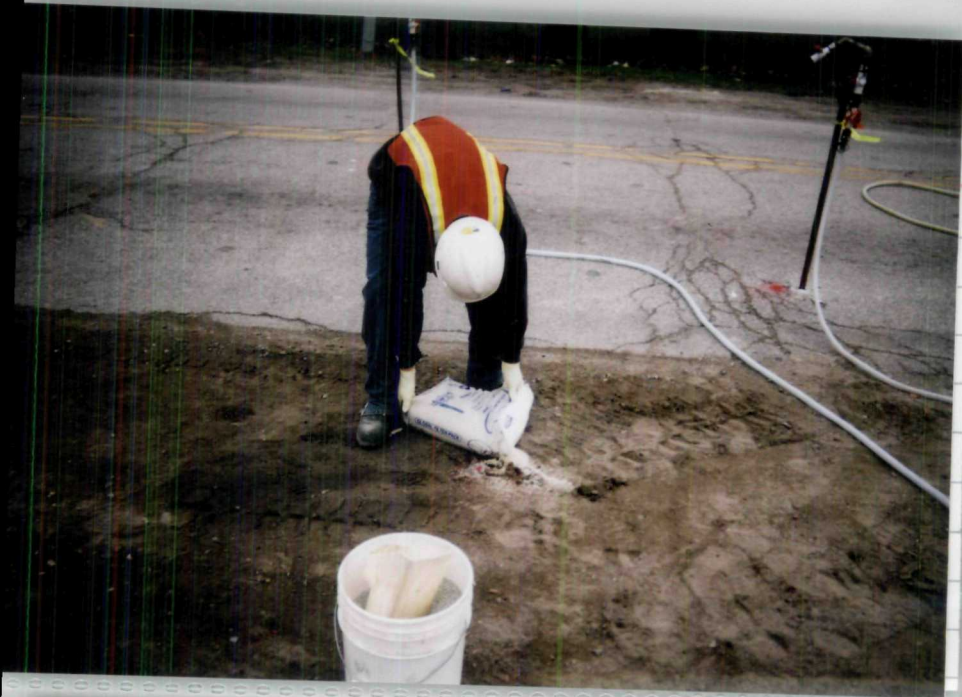
Site: American Chemical Service, Inc.  
 Proj. #: 44728 AES [46526 RAC]  
 Roll: 84 Photo #27  
 Date: 4-07-06 Time: 1122  
 Photographer: Larry Campbell  
 Description: Photo facing east showing PSA  
 backfilling injection point hole with sand.

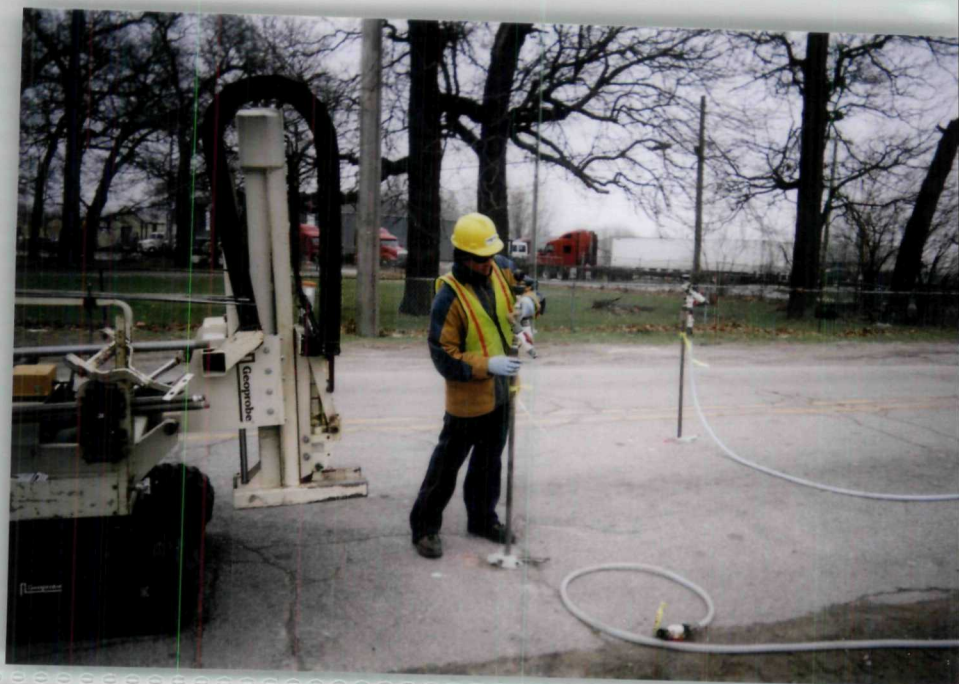
Site: American Chemical Service, Inc.  
 Proj. #: 44728 AES [46526 RAC]  
 Roll: 84 Photo #28  
 Date: 4-07-06 Time: 1127  
 Photographer: Larry Campbell  
 Description: Photo facing east showing ISOTEC  
 connecting chemox manifold to injection  
 rod.

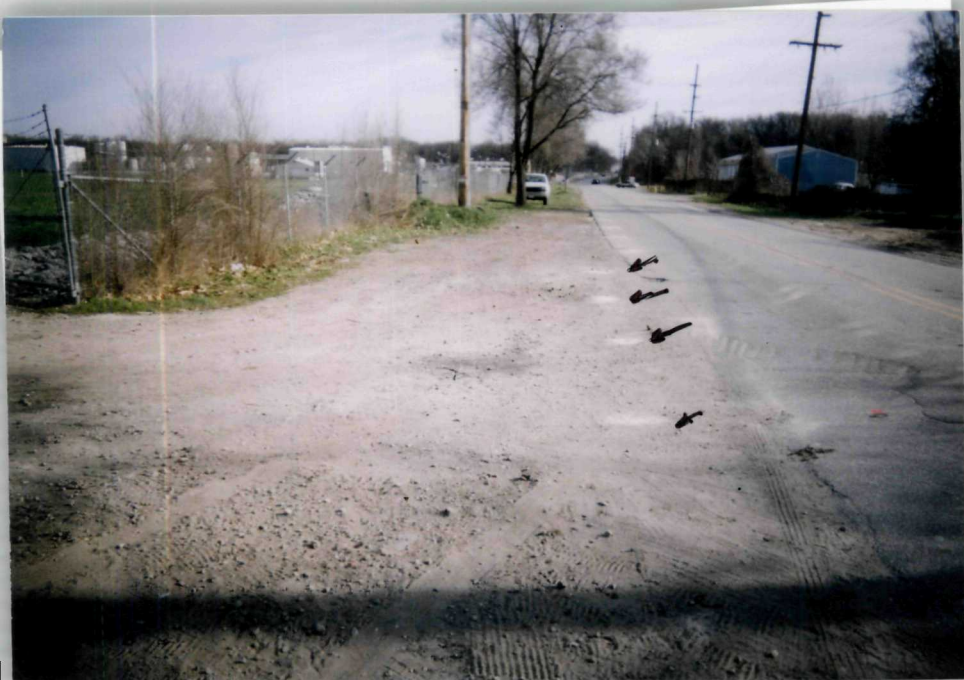
Site: American Chemical Service, Inc.  
Proj. #: 44728 AES [46526 RAC]  
Roll: 85 Photo #1  
Date: 4-11-06 Time: 0850  
Photographer: Larry Campbell  
Description: Photo facing north showing sandy locations at chemox injection points on west shoulder of Colfax Ave.

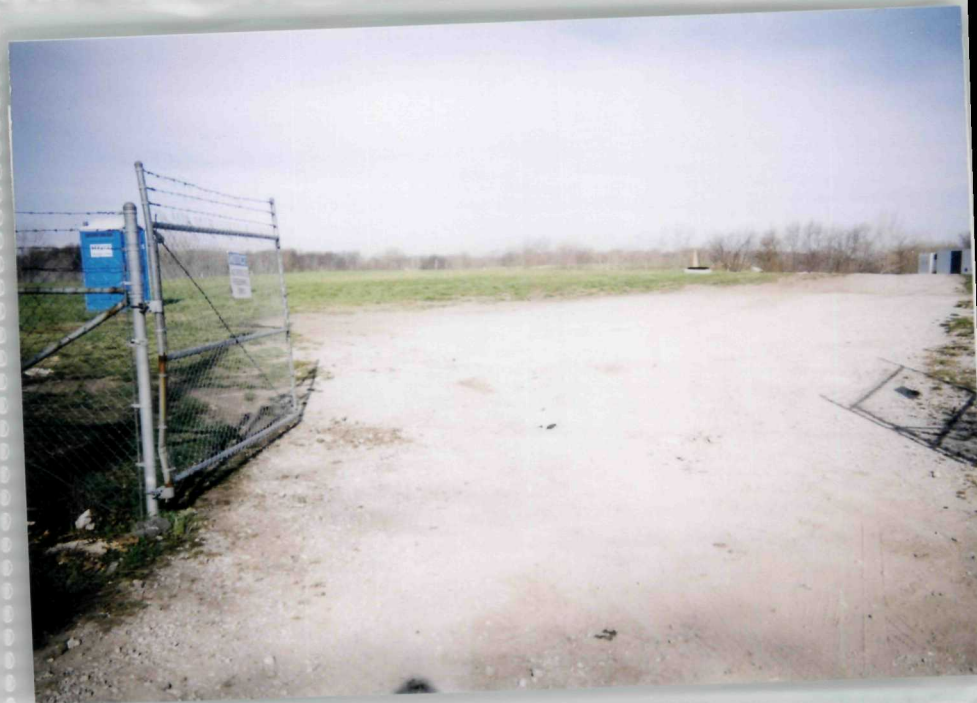
Site: American Chemical Service, Inc.  
Proj. #: 44728 AES [46526 RAC]  
Roll: 85 Photo #2  
Date: 4-11-06 Time: 0851  
Photographer: Larry Campbell  
Description: Photo facing west into OFCA at location where ISOTEC chemox staging and mixing area had been located.

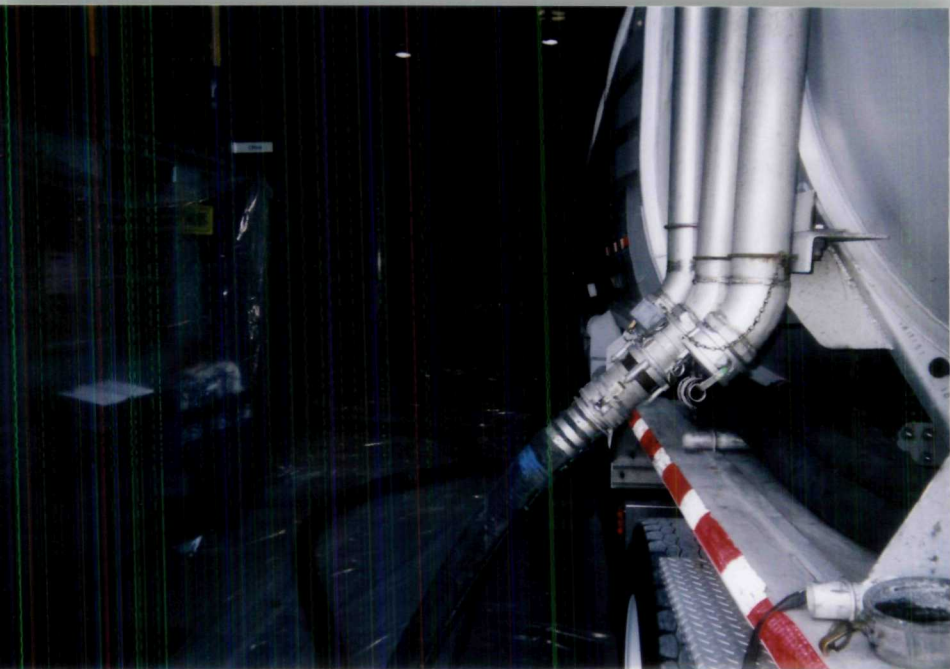
Site: American Chemical Service, Inc.  
 Proj. #: 44728 AES [46526 RAC]  
 Roll: 85 Photo #3  
 Date: 4-11-06 Time: 0902  
 Photographer: Larry Campbell  
 Description: Photo facing south into GWTP showing granular activated carbon (GAC) tanker truck and hoses. Note plastic sheeting to protect GWTP walls from carbon dust.

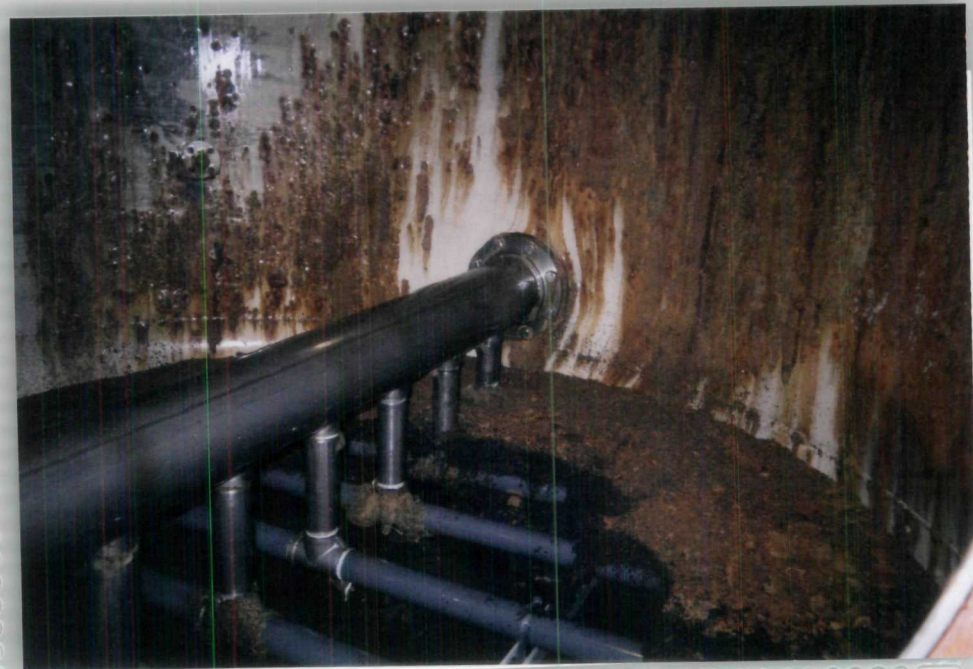
Site: American Chemical Service, Inc.  
 Proj. #: 44728 AES [46526 RAC]  
 Roll: 85 Photo #4  
 Date: 4-11-06 Time: 0903  
 Photographer: Larry Campbell  
 Description: Photo facing southwest looking into GAC tank ME34 (south tank) showing some remaining spent carbon in bottom of tank after most had been removed.

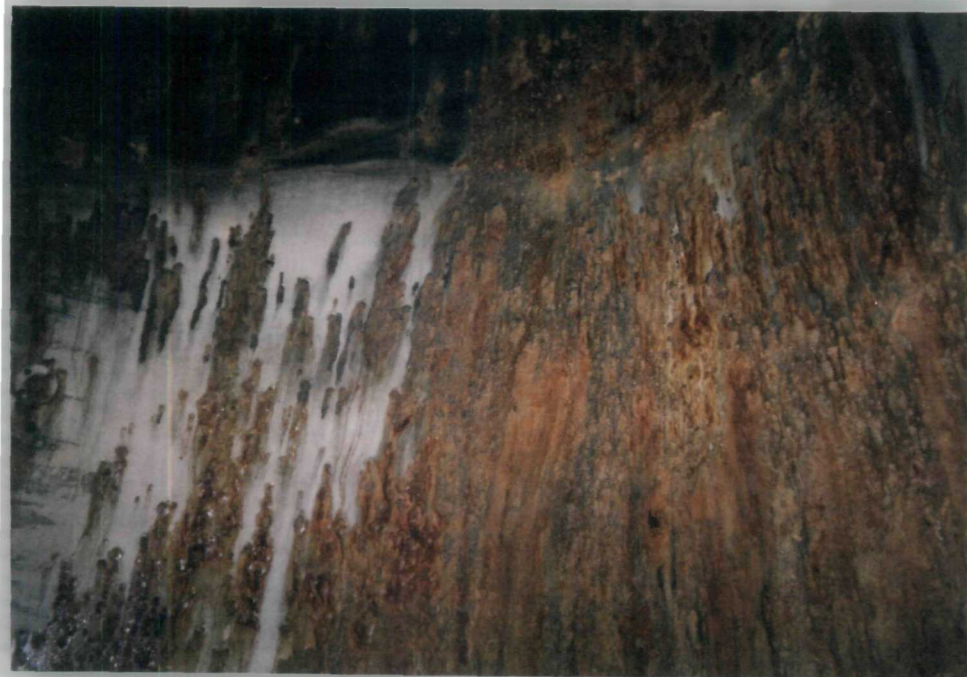
Site: American Chemical Service, Inc.  
Proj. #: 44728 AES [46526 RAC]  
Roll: 85 Photo #5  
Date: 4-11-06 Time: 0905  
Photographer: Larry Campbell  
Description: Photo looking inside GAC tank ME34  
showing corrosion on wall of tank.

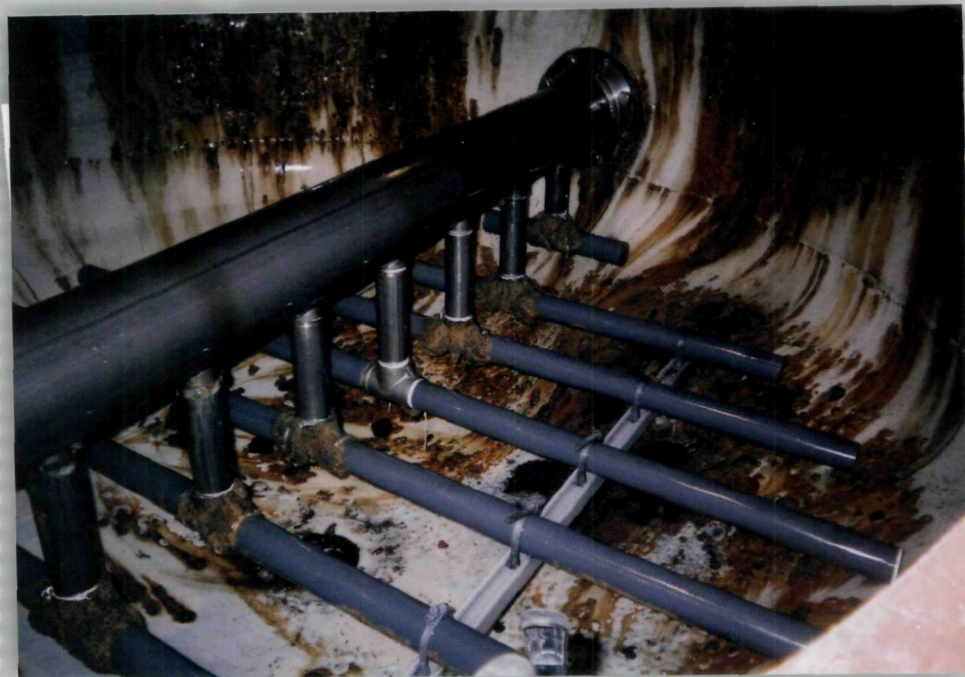
Site: American Chemical Service, Inc.  
Proj. #: 44728 AES [46526 RAC]  
Roll: 85 Photo #6  
Date: 4-11-06 Time: 0917  
Photographer: Larry Campbell  
Description: Photo looking into GAC tank ME34 after  
almost all GAC had been removed.

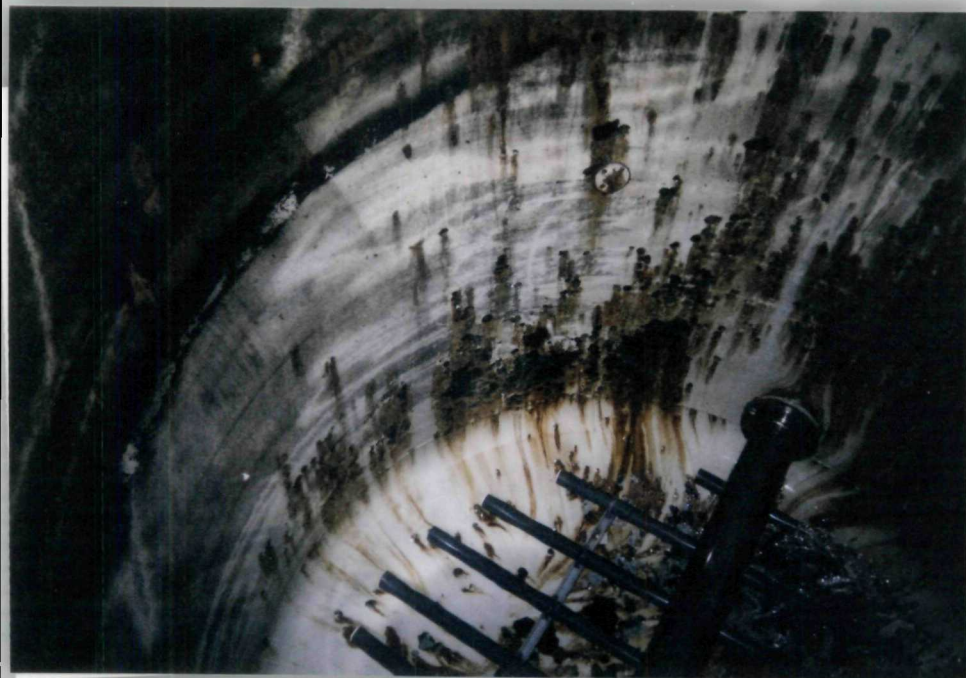
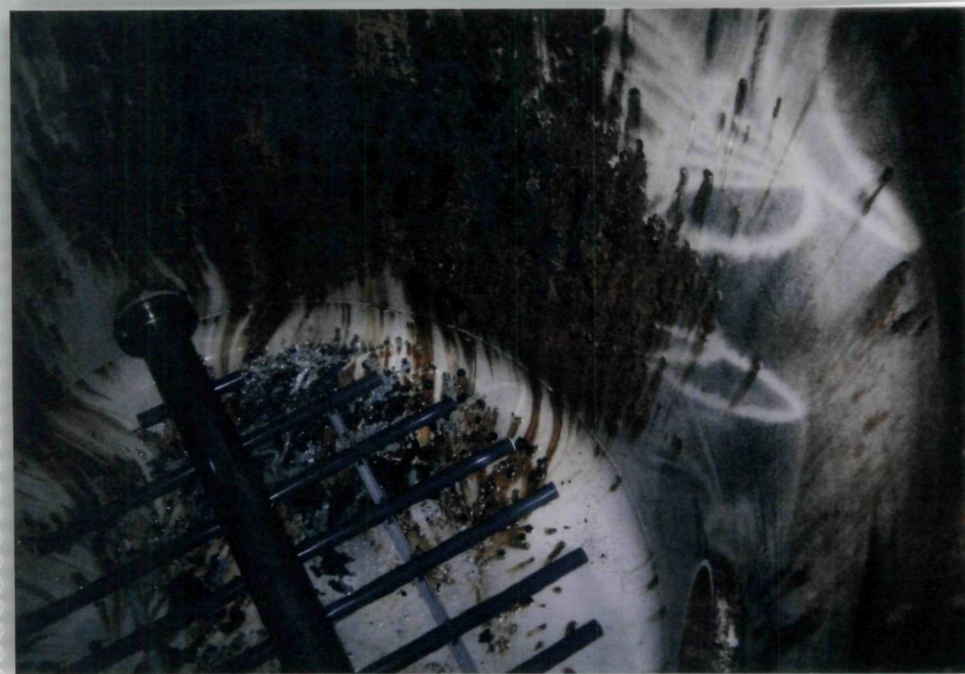
Site: American Chemical Service, Inc.  
Proj. #: 44728 AES [46526 RAC]  
Roll: 85 Photo #9  
Date: 4-11-06 Time: 0948  
Photographer: Larry Campbell  
Description: Photo (panorama 1 of 2) looking down  
inside GAC tank ME34 after all GAC has  
been removed.

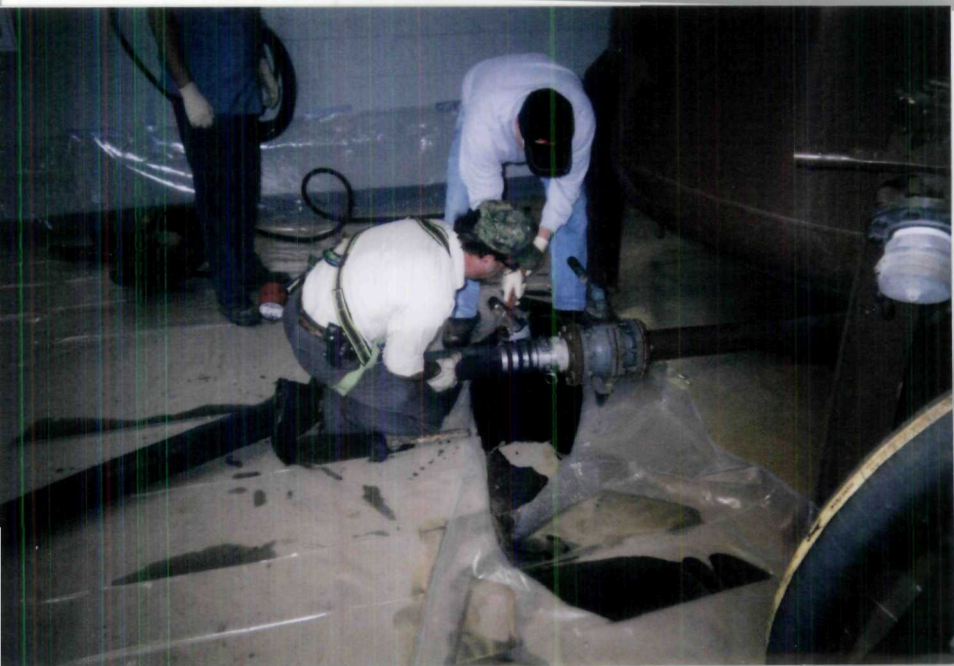
Description: Photo facing east showing Weavertown technician connecting evacuation hose to GAC tank ME33 (north tank). Black on plastic is leaked carbon.

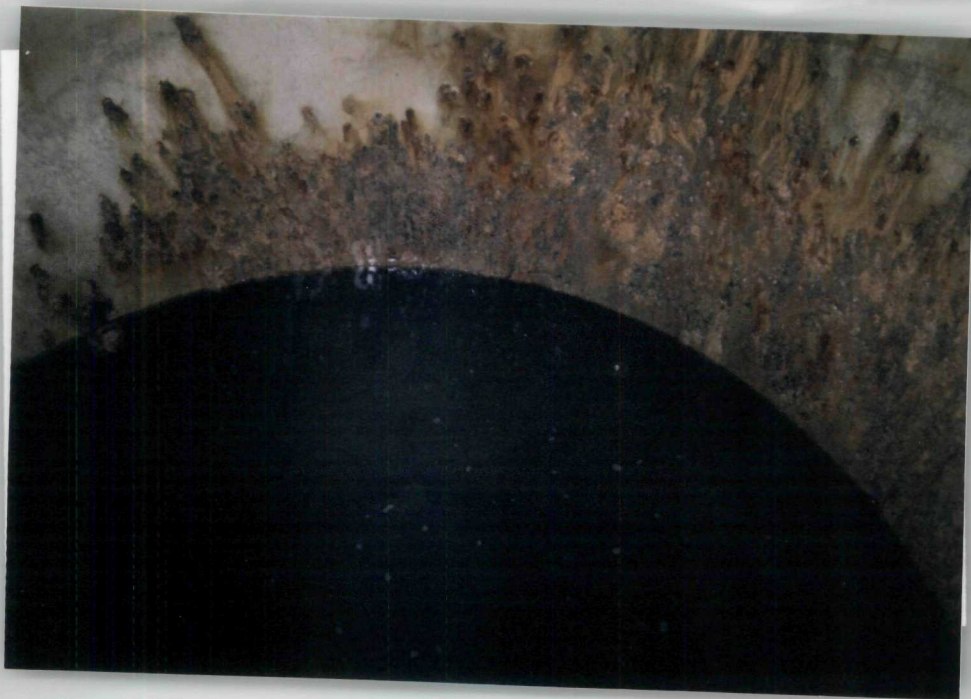
Site: American Chemical Service, Inc.  
Proj. #: 44728 AES [46526 RAC]  
Roll: 85 Photo #13  
Date: 4-11-06 Time: 1110  
Photographer: Larry Campbell  
Description: Photo facing down into GAC tank ME33  
showing water above GAC which is  
about 3/4th full in tank

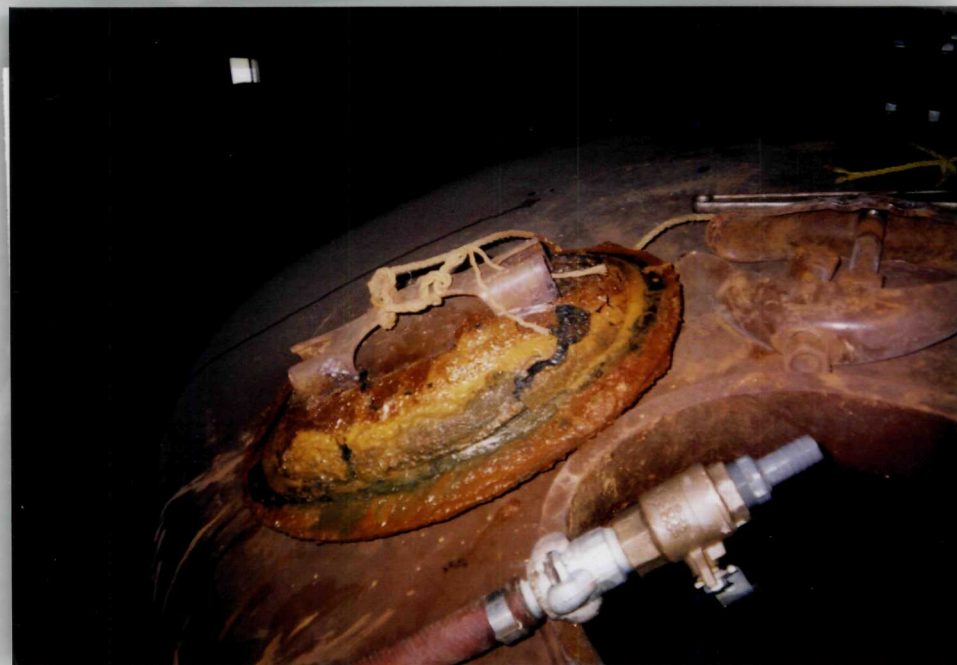
Site: American Chemical Service, Inc.  
Proj. #: 44728 AES [46526 RAC]  
Roll: 85 Photo #14  
Date: 4-11-06 Time: 1111  
Photographer: Larry Campbell  
Description: Photo facing south showing seal plate for  
access to top of GAC tank ME33. Note  
corrosion and attached carbon.
